Inspection Report

1 Crandon Street, Gosnells, WA, 6110

Visual Termite Inspection Report in accordance with AS 3660.2-2000

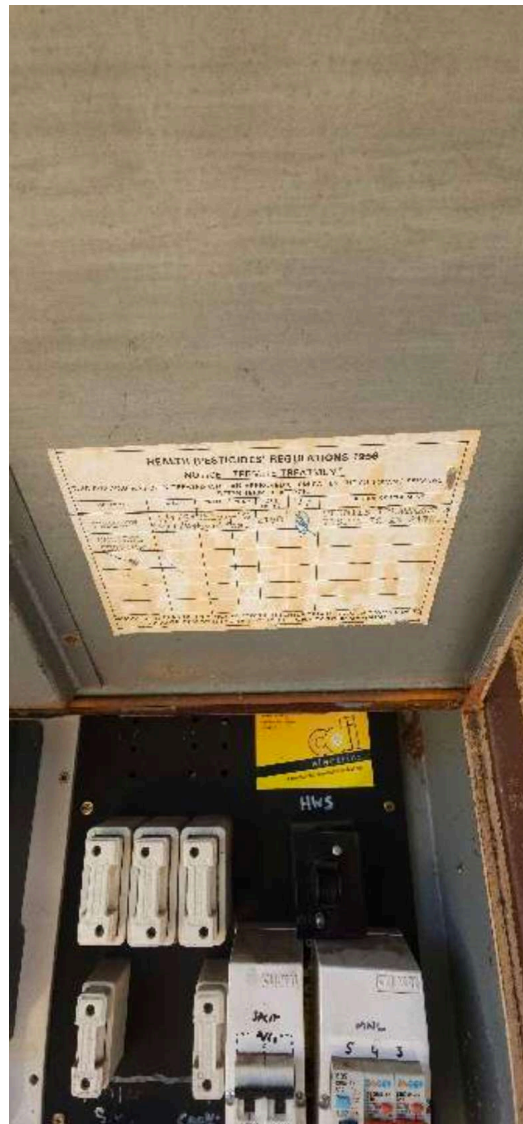
Meter Box

A durable sign was located. It indicates a previous treatment was carried out.

The treatment indicated is a chemical treated zone.
