**13 Murace Place, Middle Swan, Western Australia**

**Pre-Purchase Structural  
Property & Timber Pest Report**

| Report number: | 8561491 |
| Inspection Date: | 24th Oct, 2023 |

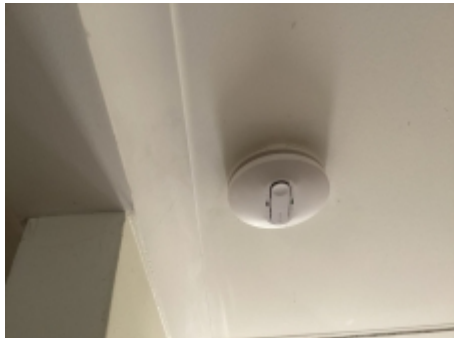
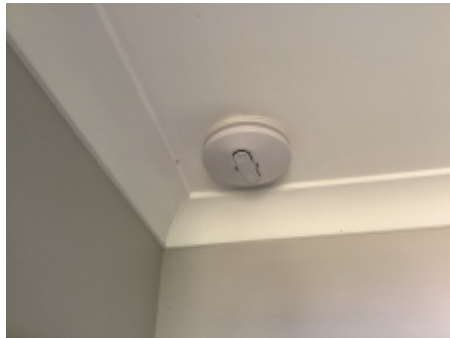
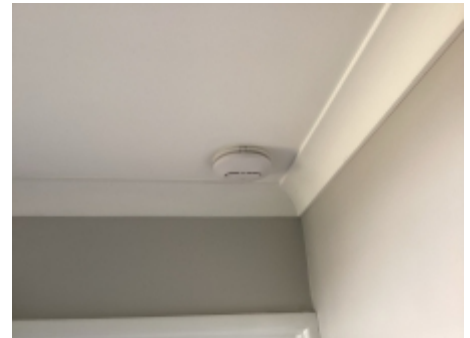
Showing examples of the smoke alarms

| Additional Comments: | Undulating/uneven path, rectify to reduce the risk of tripping and personal injury. Smoke alarm placement recommend repair to prevent possible personal injury. |

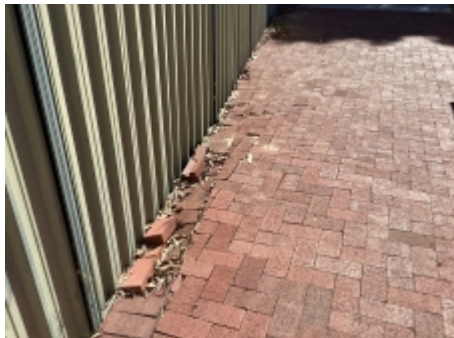
Showing undulating/uneven path

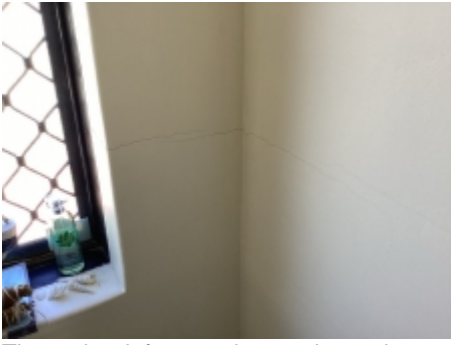
The major defect as observed constitutes a structural defect to the requirements of AS 4349.1-2007, Cracking observed to parts of the internal walls. Recommend a structural engineer be engaged to inspect and provide appropriate advice and recommendations to reduce the risk of further deterioration to the building.

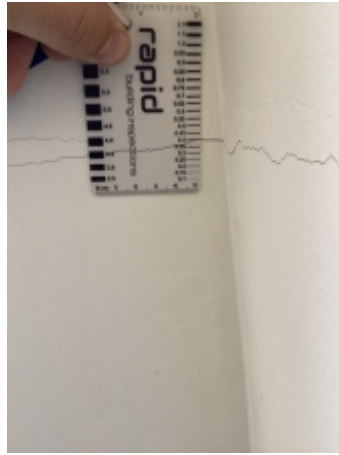
The major defect as observed constitutes a structural defect to the requirements of AS 4349.1-2007, Cracking observed to parts of the internal walls. Recommend a structural engineer be engaged to inspect and provide appropriate advice and recommendations to reduce the risk of further deterioration to the building.

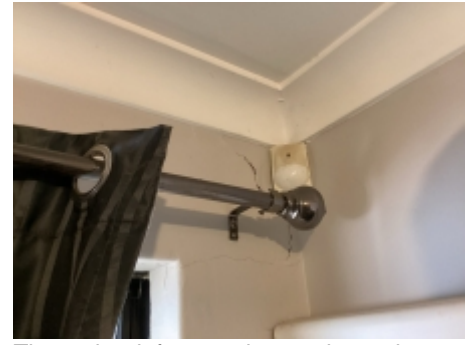
The major defect as observed constitutes a structural defect to the requirements of AS 4349.1-2007, Cracking observed to parts of the internal walls. Recommend a structural engineer be engaged to inspect and provide appropriate advice and recommendations to reduce the risk of further deterioration to the building.

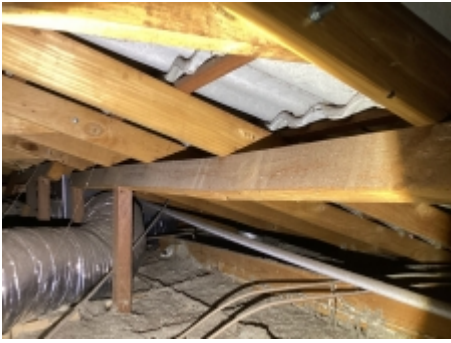
The major defect as observed constitutes a structural defect to the requirements of AS 4349.1-2007, Under purlin has cracked recommend engaging a builder to investigate further and repair as required

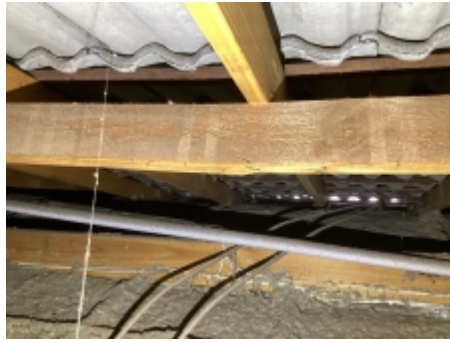
The major defect as observed constitutes a structural defect to the requirements of AS 4349.1-2007, Under purlin has cracked recommend engaging a builder to investigate further and repair as required

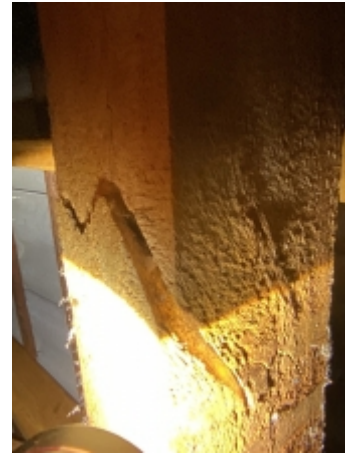
The major defect as observed constitutes a structural defect to the requirements of AS 4349.1-2007, Under purlin has cracked recommend engaging a builder to investigate further and repair as required

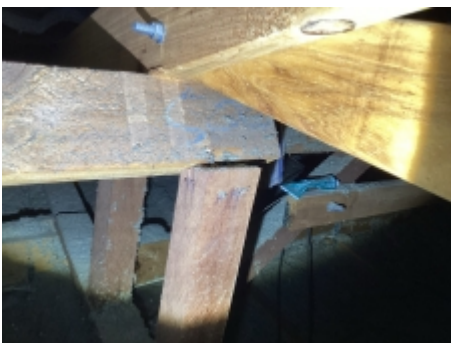
The major defect as observed constitutes a structural defect to the requirements of AS 4349.1-2007, Under purlin observed to be moving recommend builder to repair

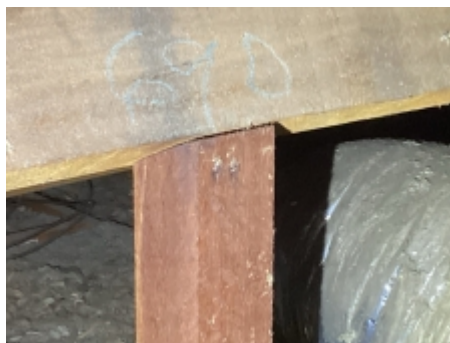
The major defect as observed constitutes a structural defect to the requirements of AS 4349.1-2007, Under purlin observed to be moving recommend builder to repair

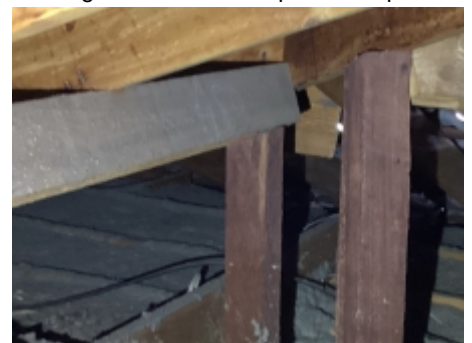
The major defect as observed constitutes a structural defect to the requirements of AS 4349.1-2007, Under purlin observed to be moving recommend builder to repair

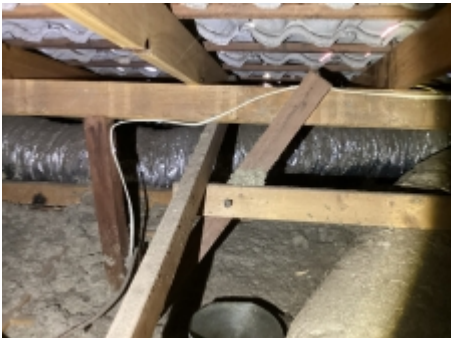
The major defect as observed constitutes a structural defect to the requirements of AS 4349.1-2007, Collar tie not installed correctly recommend builder to investigate further and repair as required

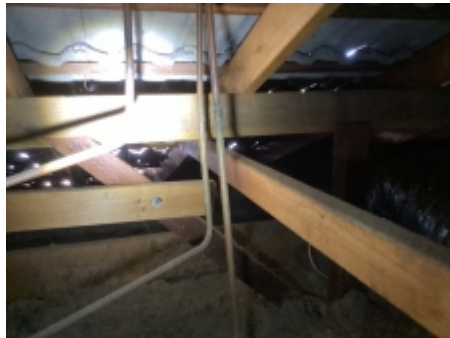
The major defect as observed constitutes a structural defect to the requirements of AS 4349.1-2007, Collar tie not installed correctly recommend builder to investigate further and repair as required

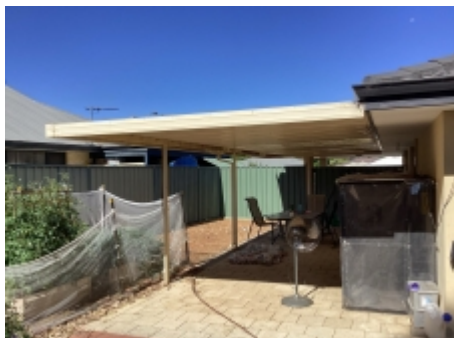
The major defect as observed constitutes a structural defect to the requirements of AS 4349.1-2007, Insufficient fixings and fasteners to the patio, recommend engaging a builder to investigate further and repair as required

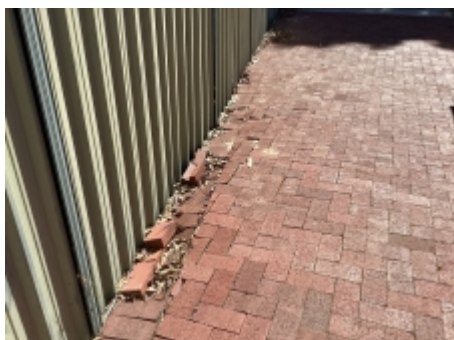
Safety issue only (non structural). It is a requirement of the inspection standard to report observed safety issues within the main body of the report., Unevenness and settling to parts of the pavers. Needs repair/replacing to prevent further deterioration.

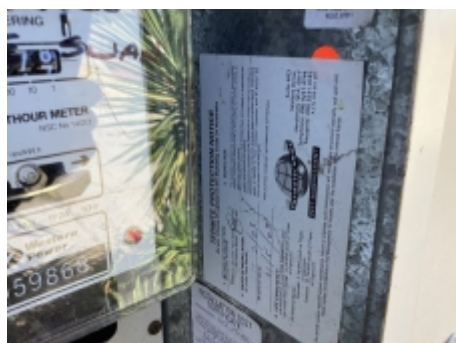
| Evidence of previous program: | Treatment sticker in meter box |

Showing examples of the sticker in the meter box

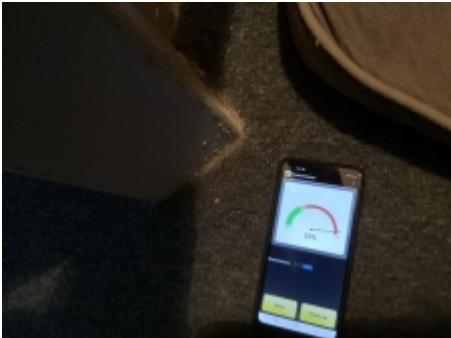
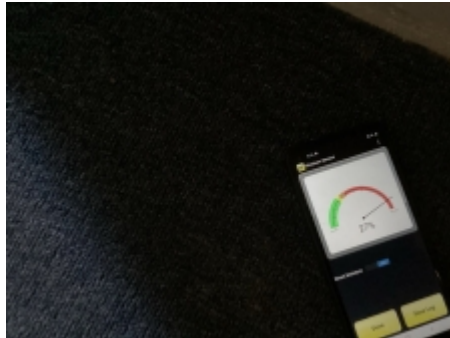
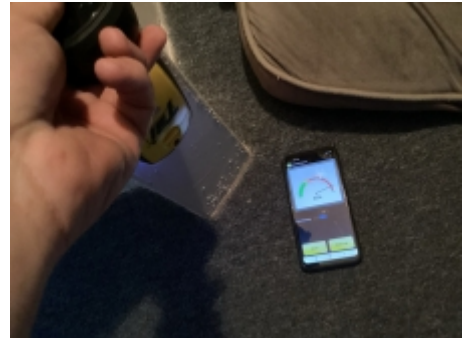
Showing examples of the high moisture readings

| Additional Comments | Walls around the shower - recommend engaging a builder for further inspection to determine if the shower needs re-building/waterproofing or is easily repaired. AC unit overflow, recommend diverting away from the building or to a suitable drain. Hot water system overflow, recommend diverting away from the building or to a suitable drain. Recommend diverting the downpipes away from the building or connecting them to the stormwater. The external taps require a drain underneath them - recommend a plumber to rectify. Downpipes require repair - recommend a plumber to rectify. Gutters require repair - recommend a plumber to rectify., Moisture stains observed, recommend builder investigate further and repair as required, Moisture stain in the roof space |

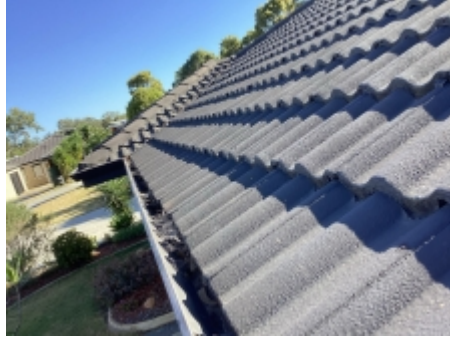
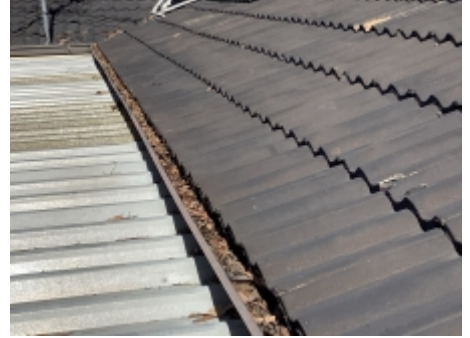
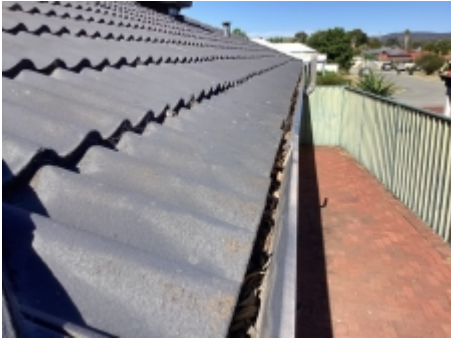
Showing examples of the debris in the gutters

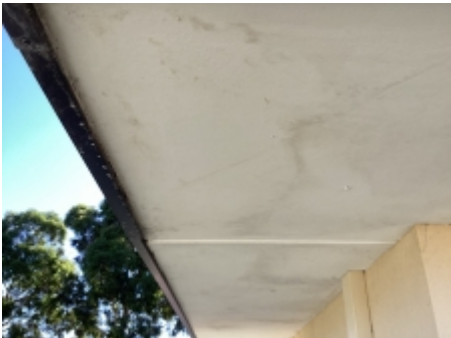
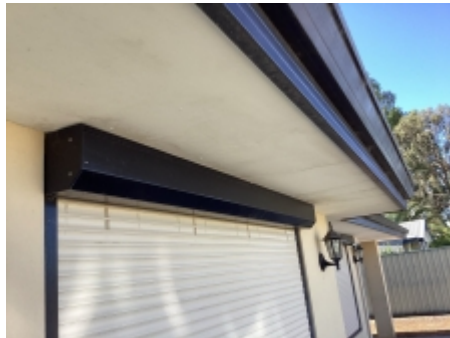
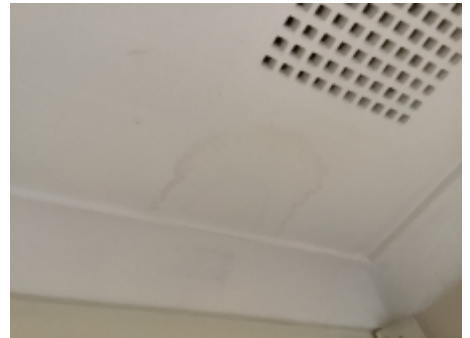
Showing examples of the moisture stains

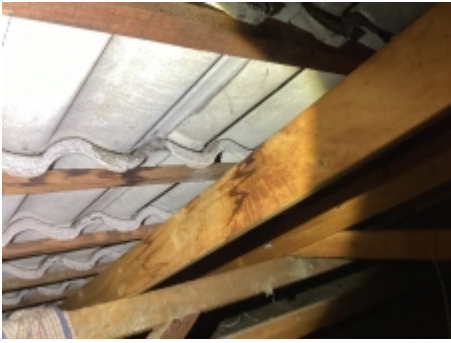
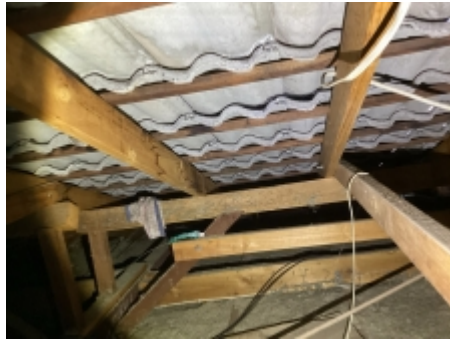
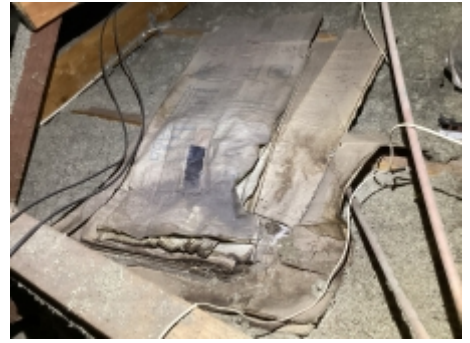
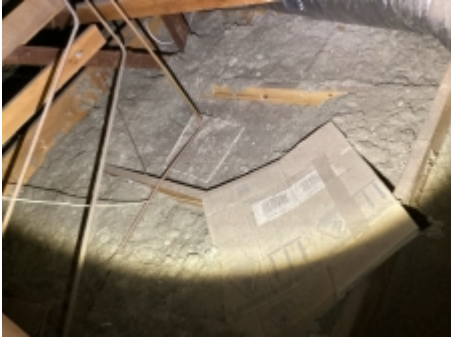
Showing examples of the moisture stains in the roof

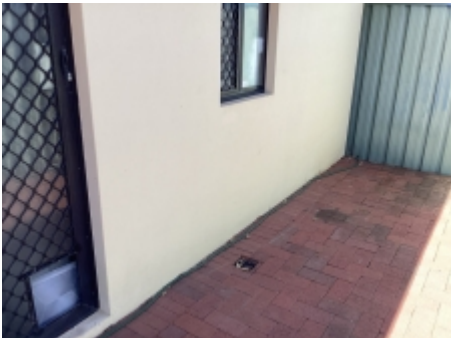
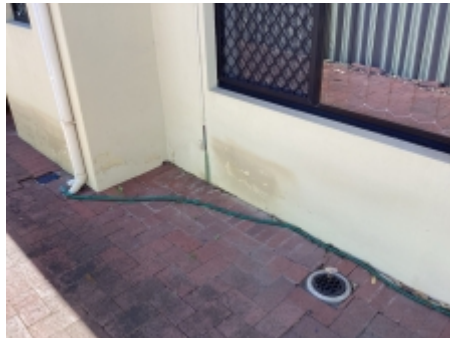
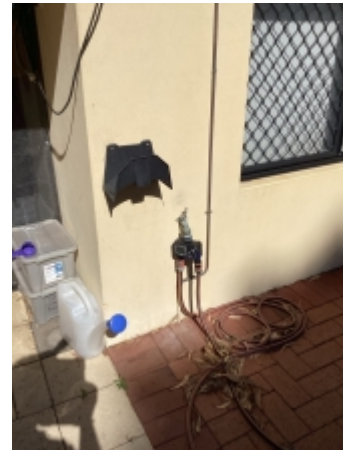
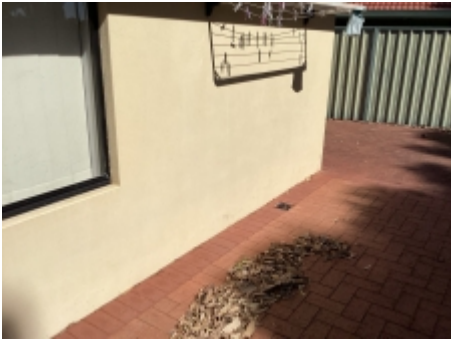
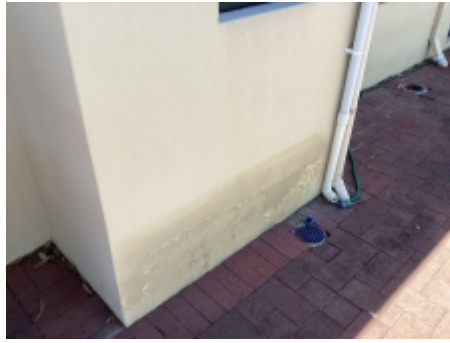
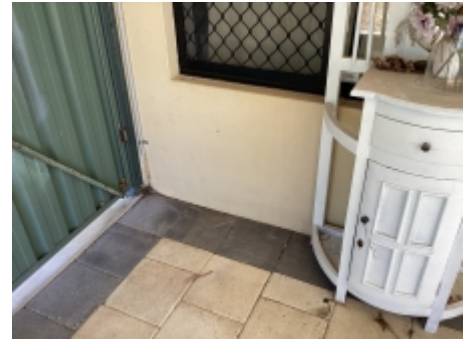
Showing examples of the covered weep holes

| Additional Comments | Obstructed weep holes - recommend exposing 75mm under weep hole to allow for visual inspection zone |
