15 Anzac Avenue Sandgate 4017 Queensland Australia

Pre-Purchase Standard Property & Timber Pest Report

Report number:	1543628
Inspection Date:	08th Apr, 2024
Property Address	15 Anzac Avenue Sandgate 4017 Queensland Australia

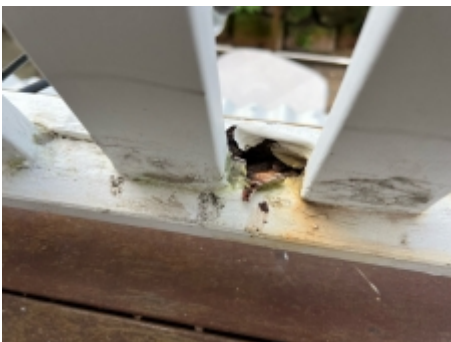
Timbers affected by fungal decay on the stairs and handrails needs to be replaced to prevent possible personal injury. A licensed carpenter should be engaged for further advice.

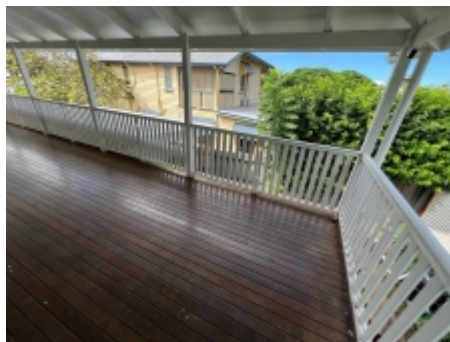
Timbers affected by fungal decay on the stairs and handrails needs to be replaced to prevent possible personal injury. A licensed carpenter should be engaged for further advice.

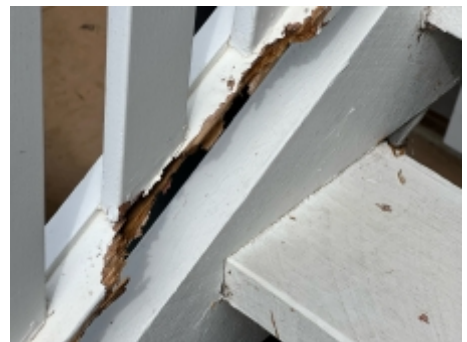
Timbers affected by fungal decay on the stairs and handrails needs to be replaced to prevent possible personal injury. A licensed carpenter should be engaged for further advice.

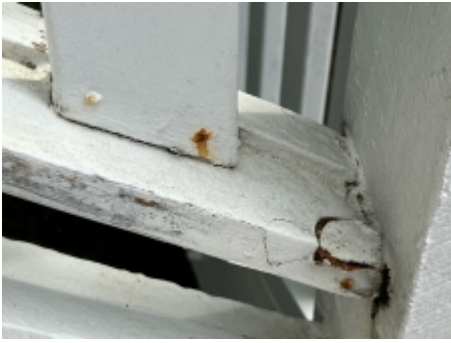
Timbers affected by fungal decay on the stairs and handrails needs to be replaced to prevent possible personal injury. A licensed carpenter should be engaged for further advice.

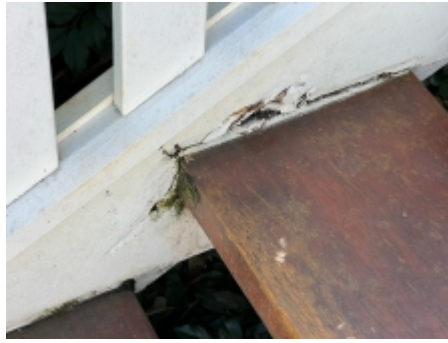
Timbers affected by fungal decay on the stairs and handrails needs to be replaced to prevent possible personal injury. A licensed carpenter should be engaged for further advice.

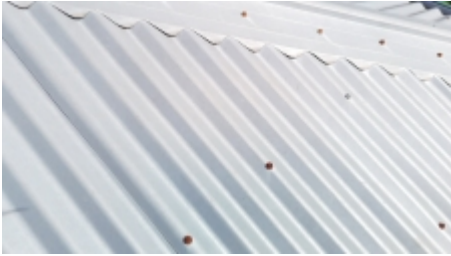
Corroded screws will eventually cause corrosion to the roofing iron which in turn leads to water ingress, a licensed roofing contractor should be engaged for further advice.

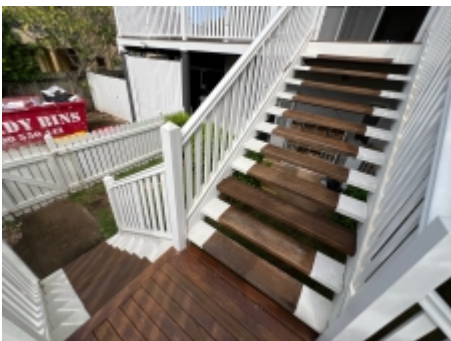
All external timbers should be sealed to prevent decay.

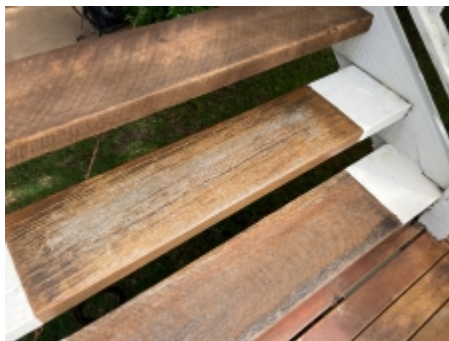
All external timbers should be sealed to prevent decay.

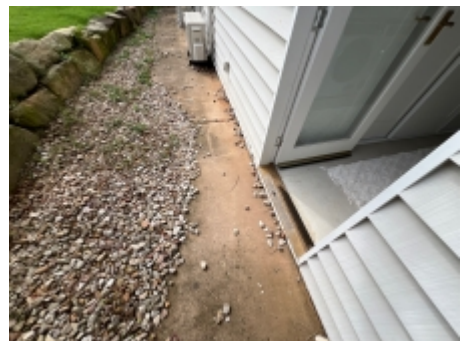
All external timbers should be sealed to prevent decay.

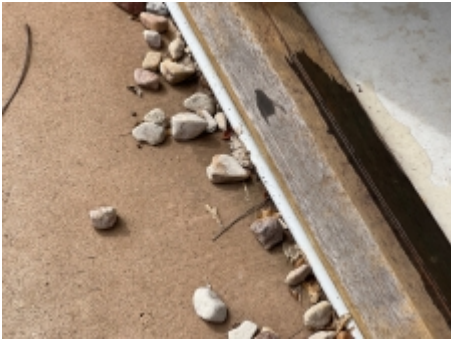
All external timbers should be sealed to prevent decay.

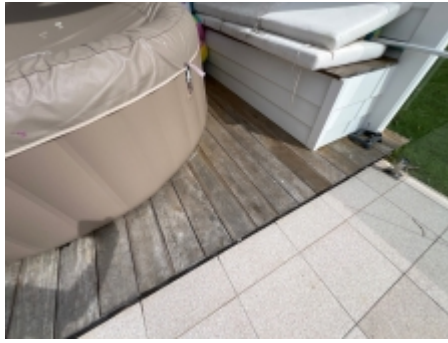
All external timbers should be sealed to prevent decay.

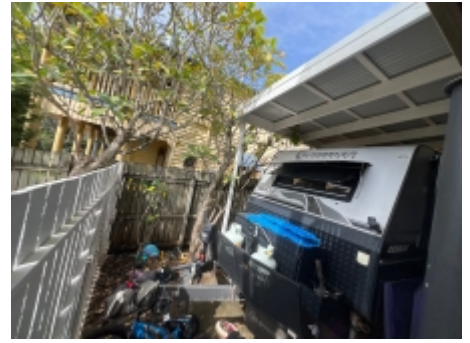
Foliage should be cleared away from all structures.

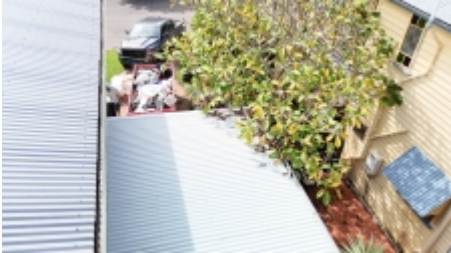
Foliage should be cleared away from all structures.

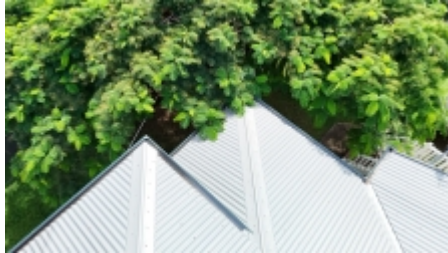
Foliage should be cleared away from all structures.

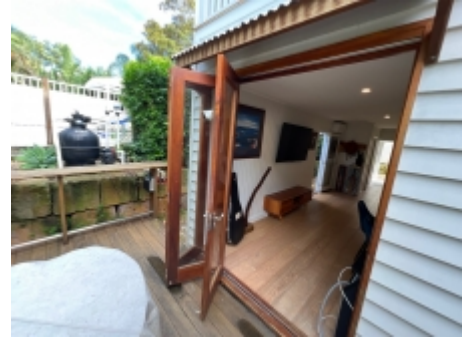
Bifold doors require servicing to allow smooth operation.

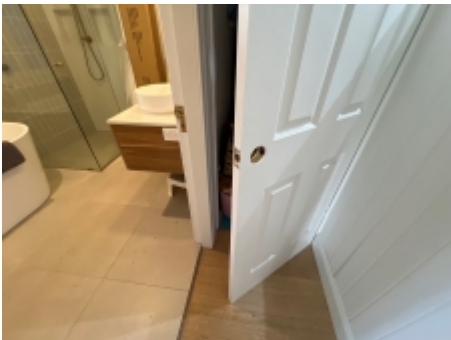
Door handle requires installation.

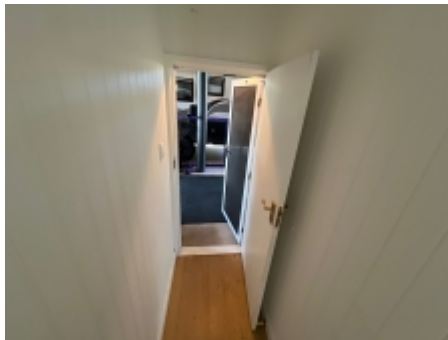
Striker plate needs to be adjusted to allow the door to latch closed.

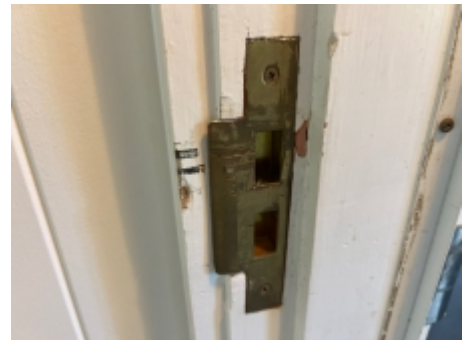
Striker plate needs to be adjusted to allow the door to latch closed.

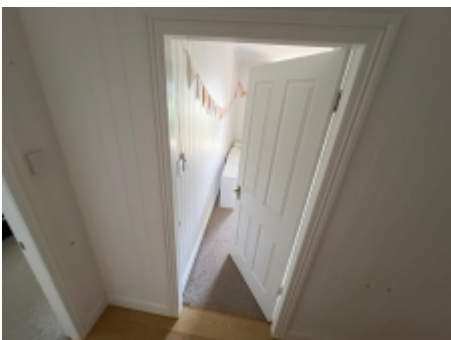
Door needs to be adjusted to allow smooth operation.

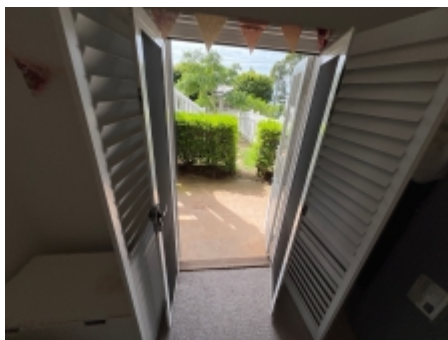
Door needs to be adjusted to allow smooth operation.

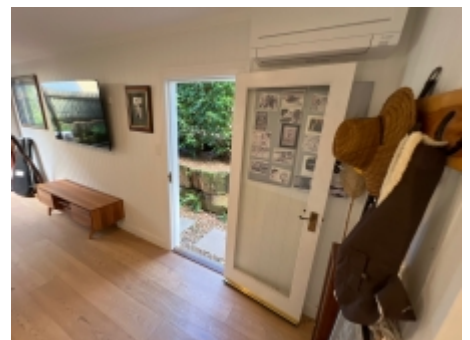
Door needs to be adjusted to allow smooth operation.

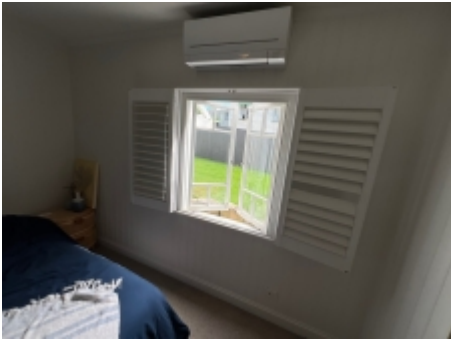
Timber windows require adjusting to allow smooth operation throughout

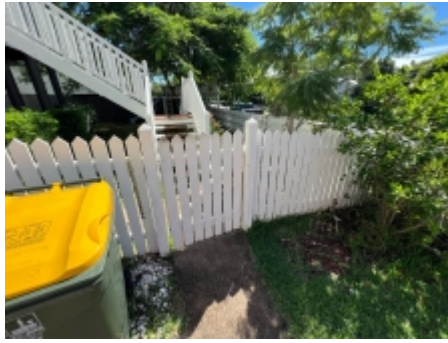
Timber fences are in varying degrees of decay and stability.

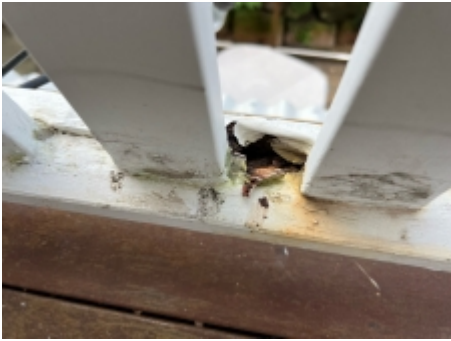
Timbers affected by fungal decay should be repaired to prevent possible timber pest attack. A licensed builder should be engaged for further advise.

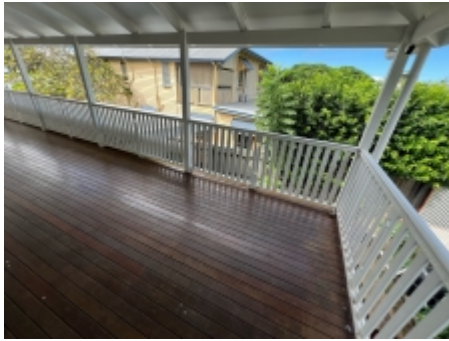
Timbers affected by fungal decay should be repaired to prevent possible timber pest attack. A licensed builder should be engaged for further advise.

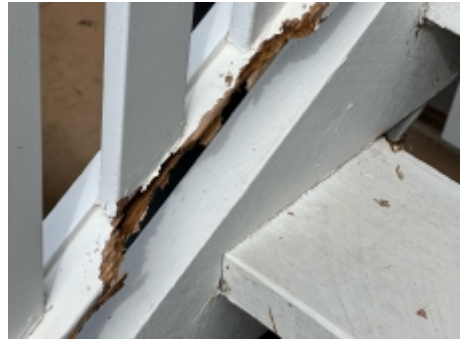
Timbers affected by fungal decay should be repaired to prevent possible timber pest attack. A licensed builder should be engaged for further advise.

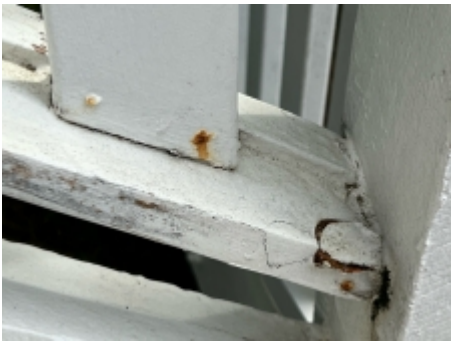
Timbers affected by fungal decay should be repaired to prevent possible timber pest attack. A licensed builder should be engaged for further advise.

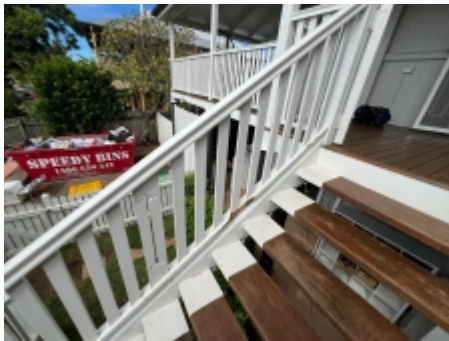
Timbers affected by fungal decay should be repaired to prevent possible timber pest attack. A licensed builder should be engaged for further advise.

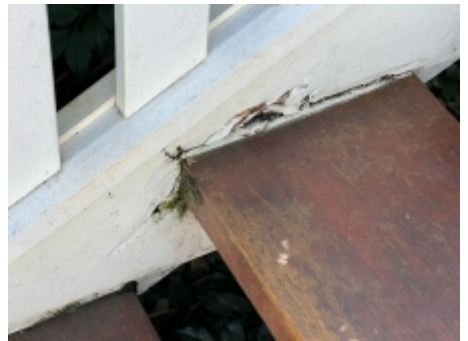
Timbers affected by fungal decay should be repaired to prevent possible timber pest attack. A licensed builder should be engaged for further advise.

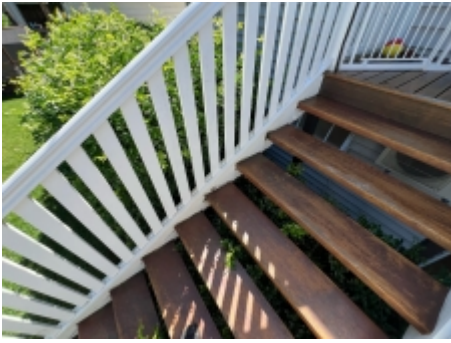
Timbers affected by fungal decay should be repaired to prevent possible timber pest attack. A licensed builder should be engaged for further advise.

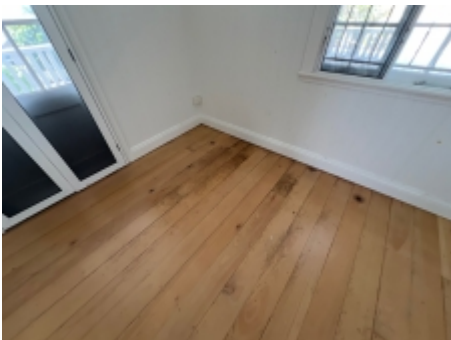
Wood borer activity was observed which is typical for this species of timber and age of construction, a pest controller should be engaged for advice on maintenance.

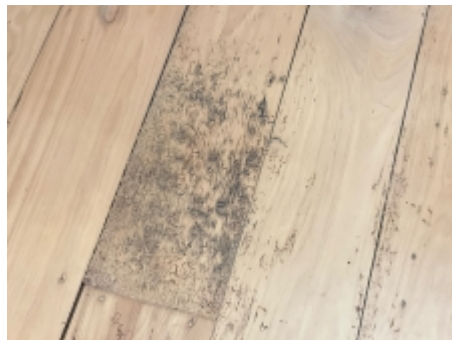
Wood borer activity was observed which is typical for this species of timber and age of construction, a pest controller should be engaged for advice on maintenance.

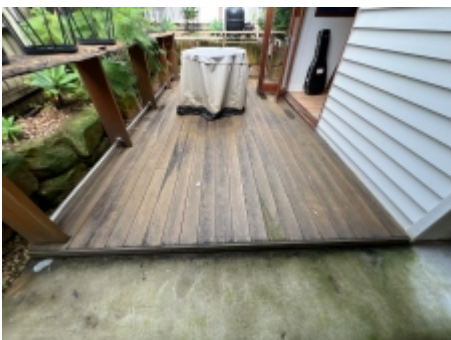
The construction methods used for the deck have left the subfloor lacking adequate ventilation which can cause fungal decay and provides concealed access for termites

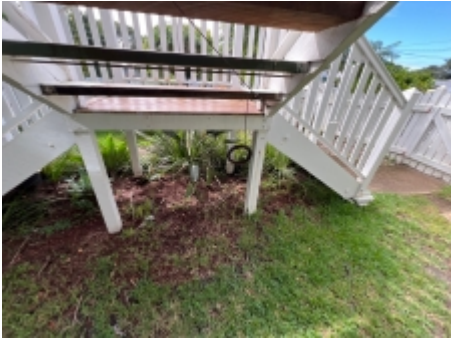
A 75 mm inspection zone should be maintained under all timber building materials where possible. A carpenter should be engaged for further advice.

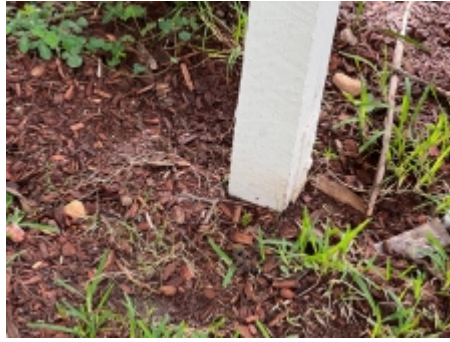
A 75 mm inspection zone should be maintained under all timber building materials where possible. A carpenter should be engaged for further advice.

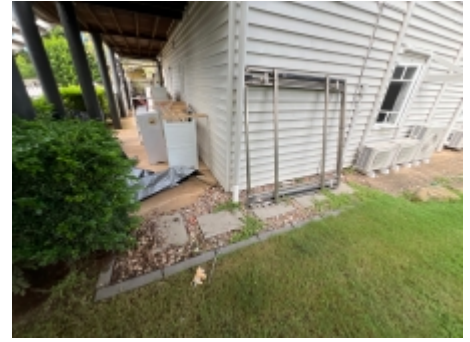
A 75 mm exposed slab edge should be maintained under all external cladding, a pest controller should be engaged for further advice.

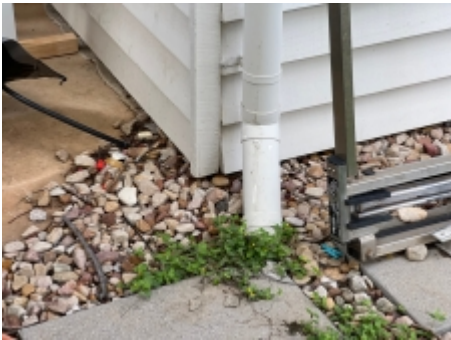
A 75 mm exposed slab edge should be maintained under all external cladding, a pest controller should be engaged for further advice.

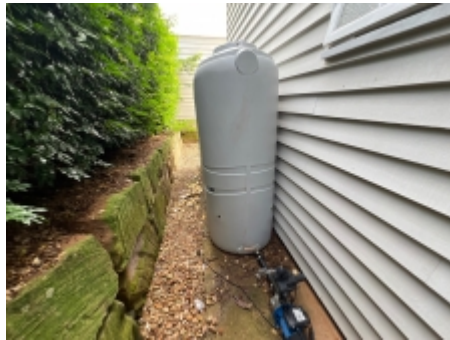
Stored goods should be moved away from the building so as not to hinder visual inspection zone's.

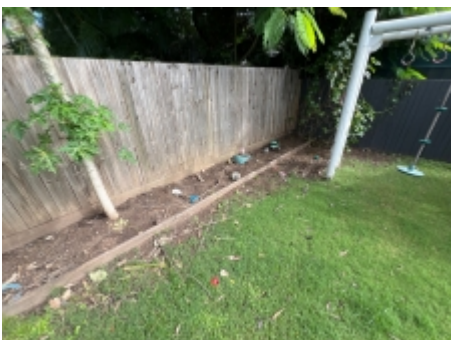
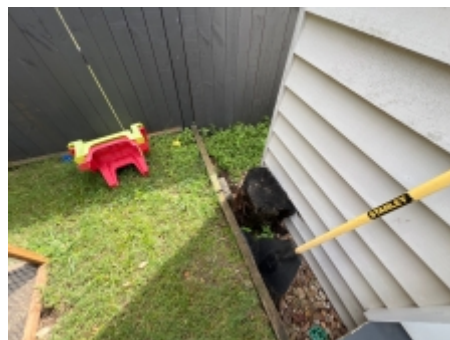
E12 Untreated or non-durable timber used in a hazardous environment	No evidence was found
E13 Other conditions conducive to timber pest attack	The following evidence was found
Comments	Timber garden edging/retaining wall isn't an ideal choice of material as this will attract termites.
