Pre-Purchase Inspection - Residential Building Report

Complies with Australian Standard AS 4349.1- 2007 Inspection of Buildings Part 1: Pre-Purchase inspections - Residential buildings

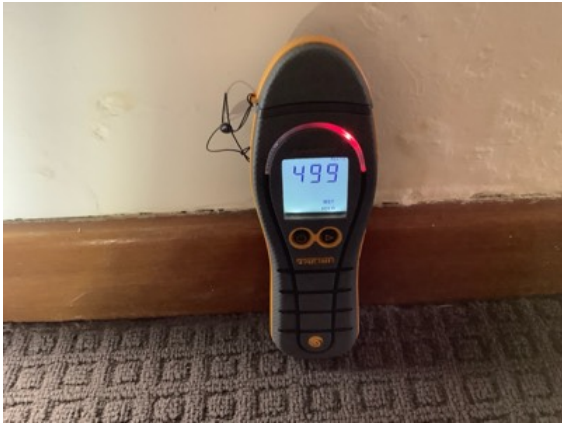
49% moisture detected to the Lounge Room wall.

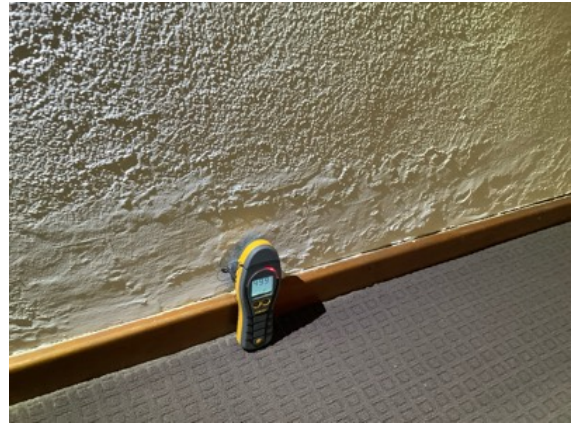
Moisture detected to the Lounge wall is located directly adjacent to the Bathroom shower recess.

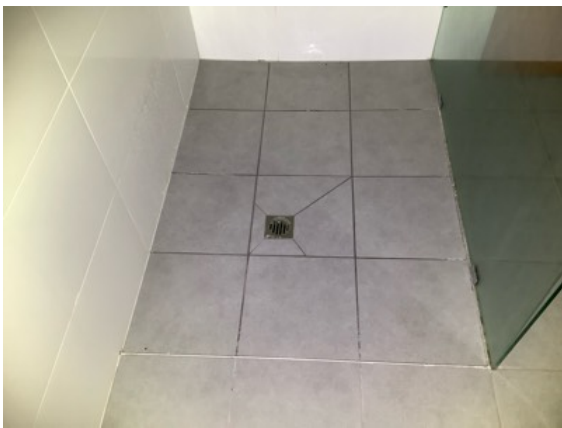
Bathroom shower recess.

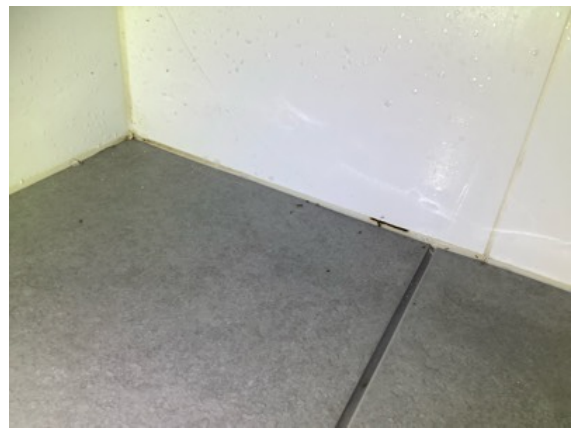
Deterioration/worn grout and sealant joints noted to the Bathroom shower recess floor and wall tiles. Recommend tiler review for repairs and re-seal to waterproof membrane.

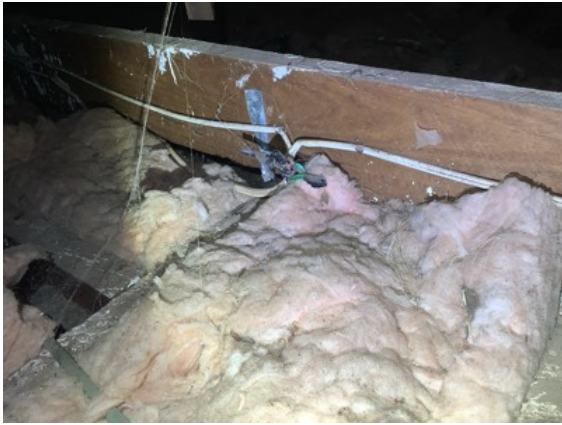
Exposed wiring junctions observed in the roof void above the Kitchen area. Recommend having an Electrician install junction box's at all connections to make safe.

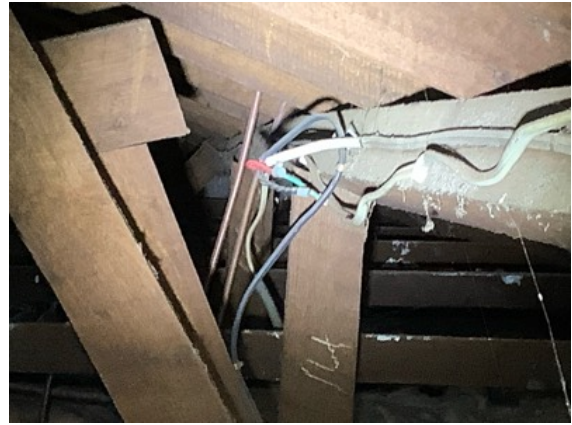
Exposed wiring junctions observed in the roof void above the Entry area. Recommend having an Electrician install junction box's at all connections to make safe.

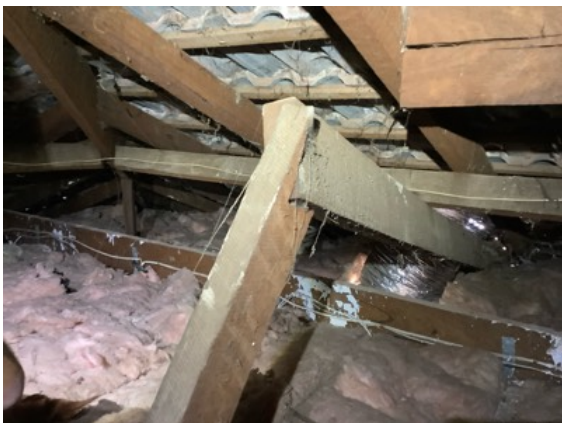
Significant twisting and failed fixings noted to the scissor strut above the Kitchen area. Repairs required.

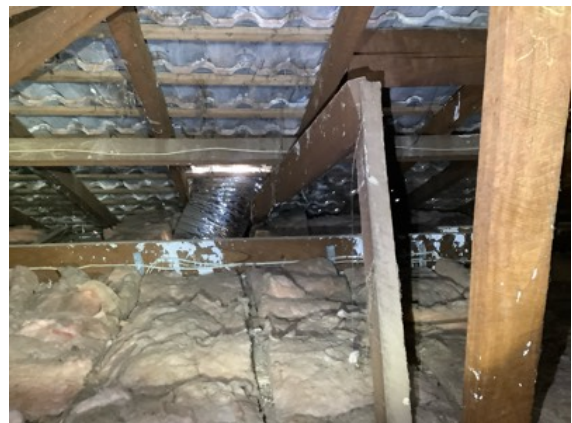
Twisting scissor strut above Kitchen area.

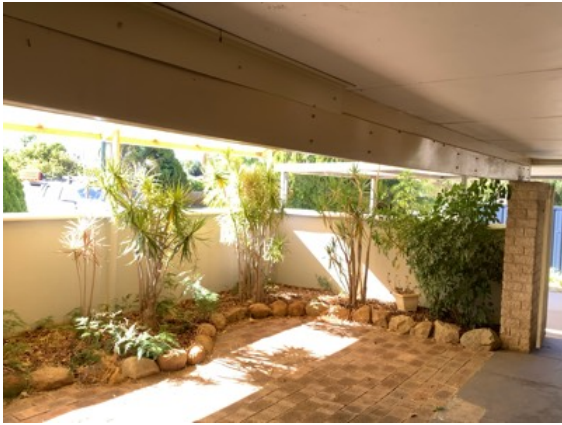
Significant deflection, distortion and sagging noted to the Verandah beam due to inadequate support. Recommend repairs which may require replacing the beam and installation of additional supports.

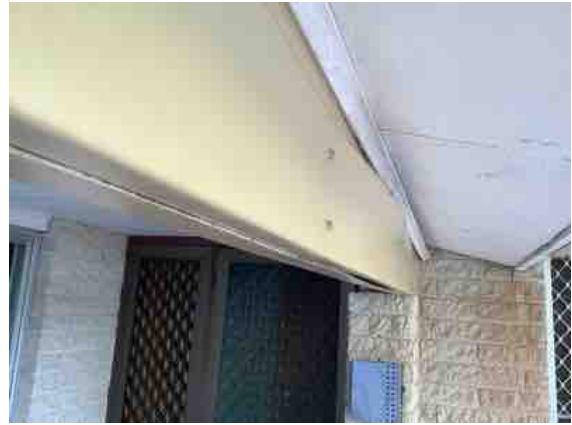
Distortion and buckling noted to the steel fitch plates installed to both sides of the Verandah beam which are failing to support the timber beam as intended. Repairs required.

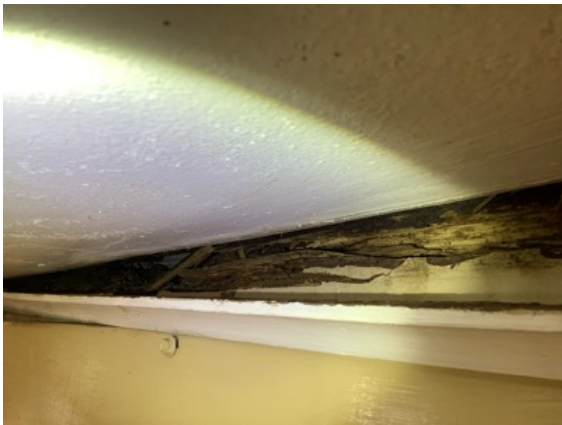
Significant wood rot damage noted to the exposed section of the timber Verandah beam. Recommend having Builder conduct an invasive inspection to the beam and roof frame to ensure there is no further concealed damage and repair as required.

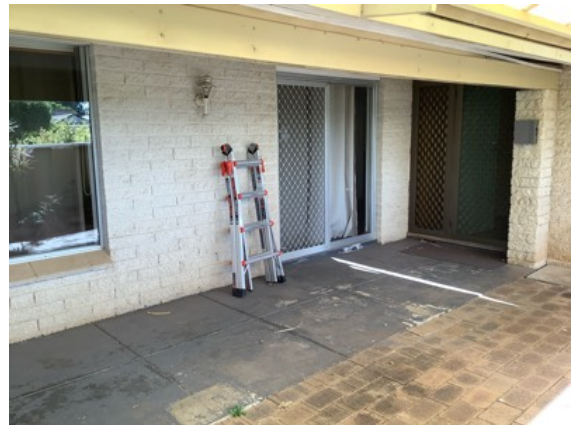
Wood rot damage and significant sagging/deflection noted to the Verandah beam. There are 2x marks on the ground where previous piers or posts appear to have been removed. Recommend invasive inspection and repairs which may require a beam replacement and additional supports installed.

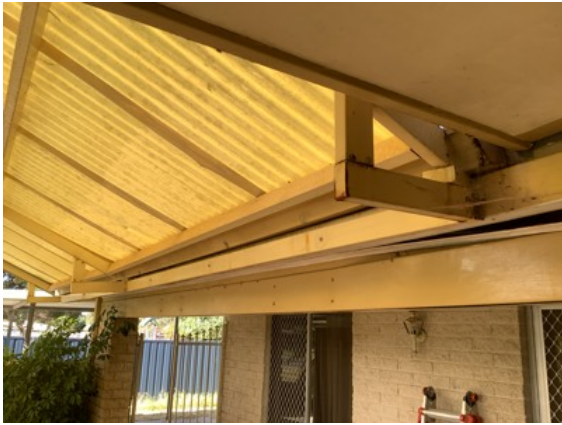
Significant damage, distortion and sagging observed at the West elevation Patio to fascia connection. Repairs, modification and/or removal is required to prevent further damage. and to make safe.

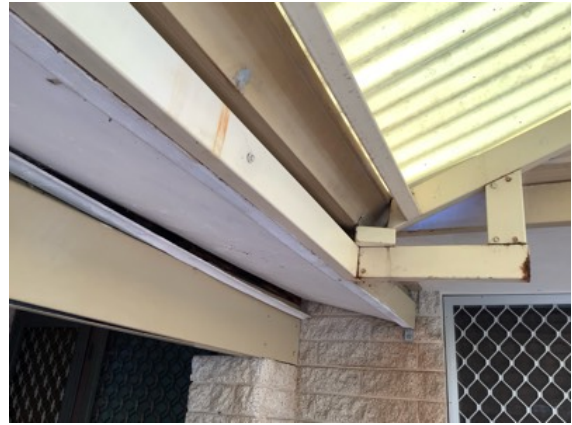
The West elevation Patio structure is connected to the metal fascia of the main residence only which is not designed to take load and has caused sagging and damage to the fascia gutter and eaves. Repairs, modification and/or removal is required to prevent further damage. and to make safe.

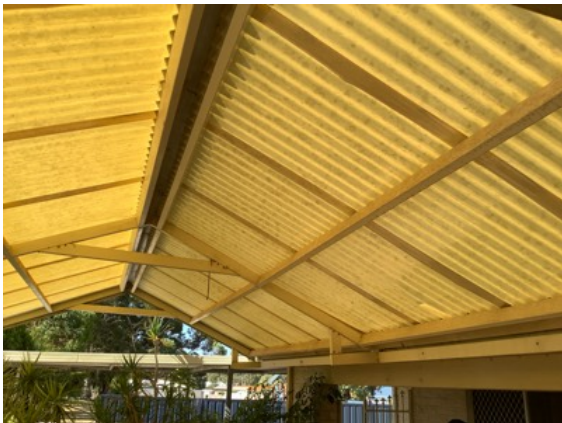
West elevation Patio structure.

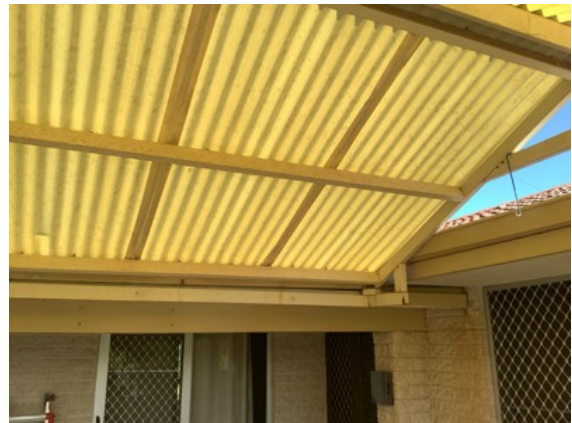
The West elevation Patio structure is connected to the metal fascia of the main residence only which is not designed to take load and has caused sagging and damage to the fascia gutter and eaves. Repairs, modification and/or removal is required to prevent further damage and to make safe.

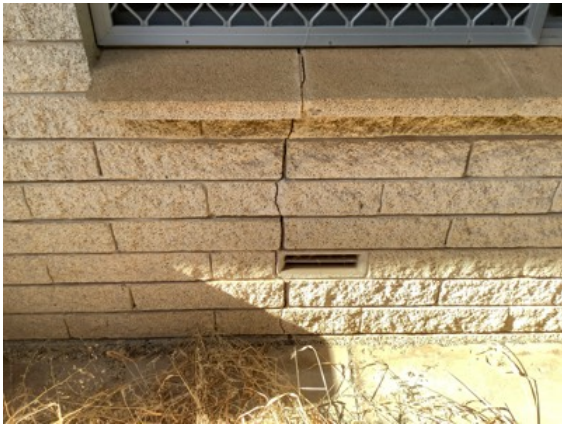
Vertical appearance cracking observed to the South elevation brick wall below the Meals area window. Recommend repairs and to monitor over time.

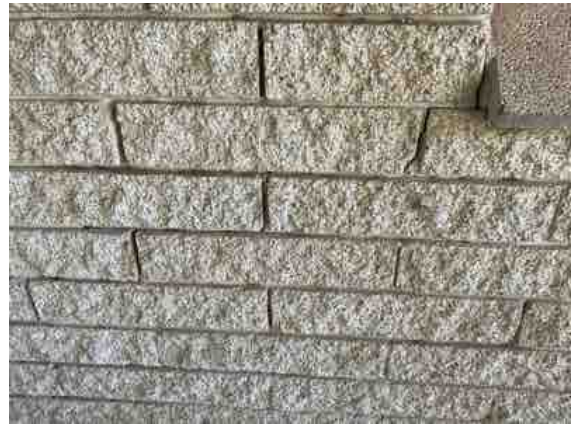
East elevation - Stepped appearance cracking noted to the exterior brick wall below the Activity Room window. Recommend maintenance/repairs and to monitor over time.

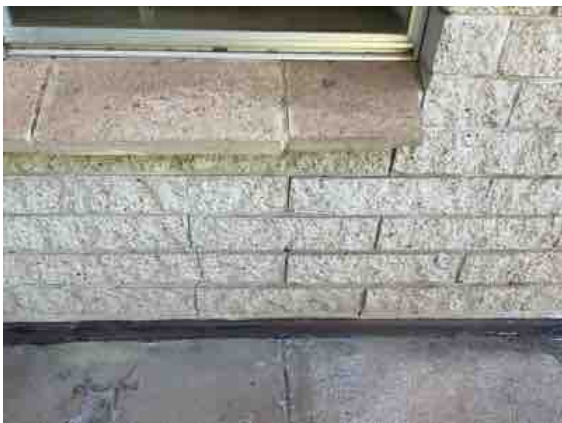
East elevation - Stepped appearance cracking noted to the exterior brick wall below the Bedroom 2 window. Recommend maintenance/repairs and to monitor over time.

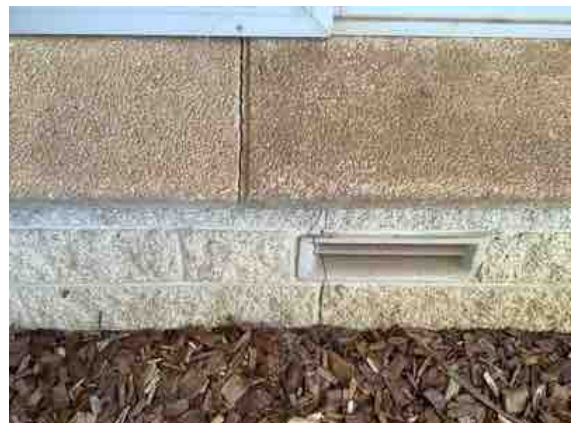
West elevation - Appearance cracking noted to the exterior brick wall below the Family Room window. Recommend maintenance/repairs and to monitor over time.

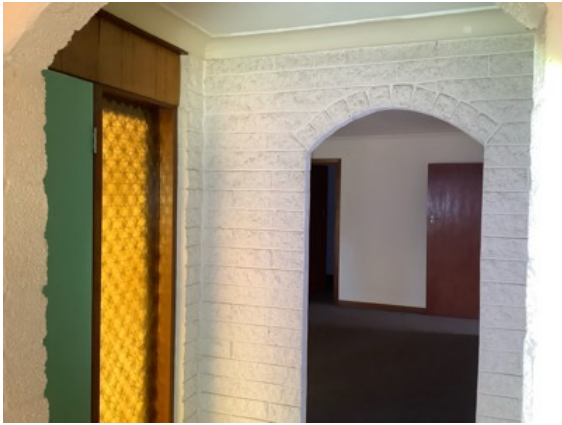
The inspector is not required to comment on individual minor defects and imperfections. If noted, it is expected that defects of this type would be rectified as part of normal ongoing property maintenance.

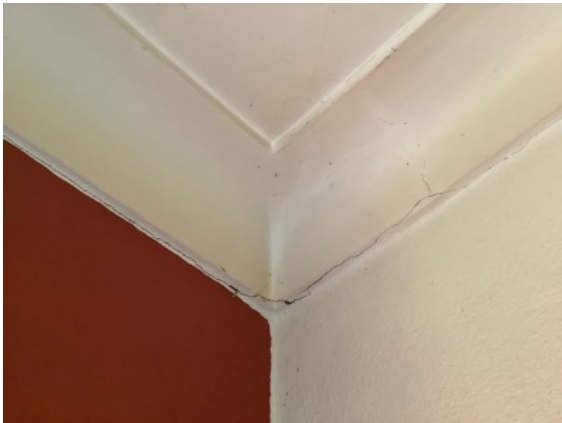
Family - Typical appearance cracking noted to the cornice and wall junctions at some isolated areas throughout the home. Recommend maintenance/repairs.

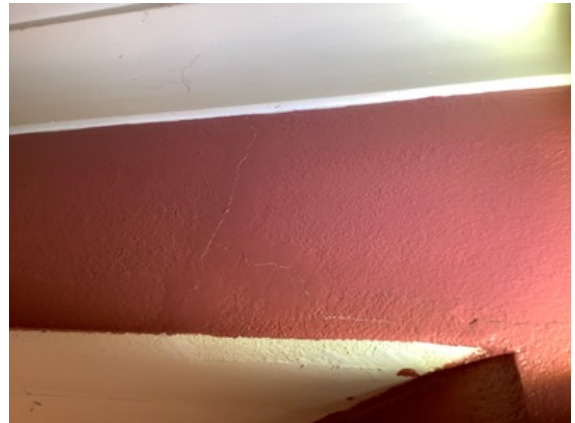
Family - Appearance cracking noted to wall linings at some isolated areas throughout the home. Recommend maintenance/repairs.

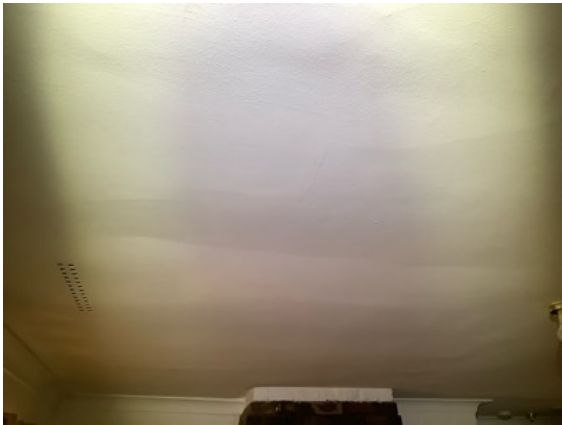
Lounge Room - Deterioration and minor sagging noted to some isolated areas throughout the home. As buildings age, so do the fixings and adhesives/lagging holding the ceiling lining in place. Recommend having a Ceiling Fixer review for possible maintenance/repairs as required.

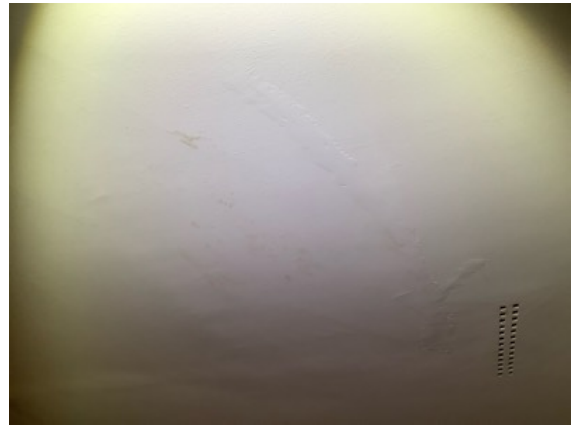
Lounge room - Evidence of moisture ingress and staining noted to the ceiling lining. This could be historical. Recommend a roof cover inspection or having a roofing contractor check above this area for repairs that may be required.

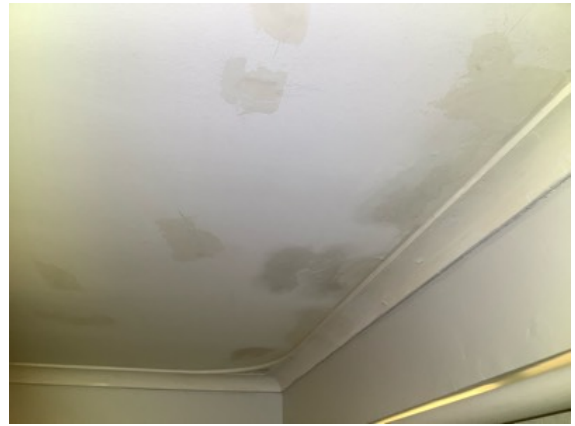
Activity Room - Evidence of moisture ingress, staining and possible mould growth noted to the ceiling lining. This could be historical. Recommend having a mould specialist review and having a roof cover inspection or having a roofing contractor check above this area for repairs that may be required.

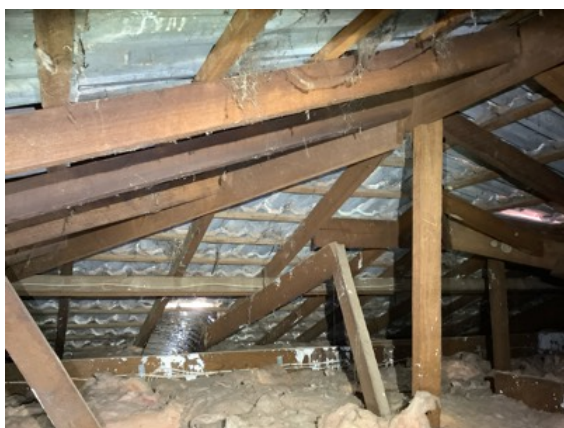
The inspector is not required to comment on individual minor defects and imperfections. If noted, it is expected that defects of this type would be rectified as part of normal ongoing property maintenance.

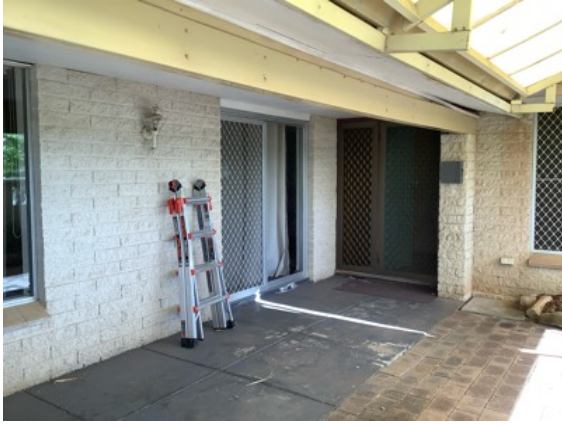
The inspector is not required to comment on individual minor defects and imperfections. If noted, it is expected that defects of this type would be rectified as part of normal ongoing property maintenance.

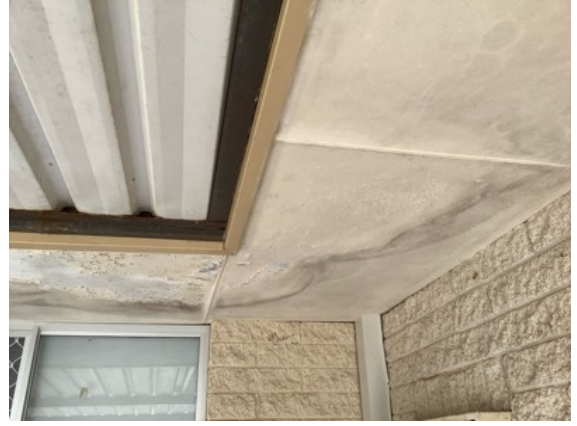
West elevation - Evidence of moisture ingress to the exterior eaves lining in some areas. Eaves can be highly susceptible to moisture, often as a result of blocked and/or leaking gutters or down pipe connections. Recommend roof cover inspection, repairs and/or routine clearing of overflow provisions to gutters and down pipes as required.

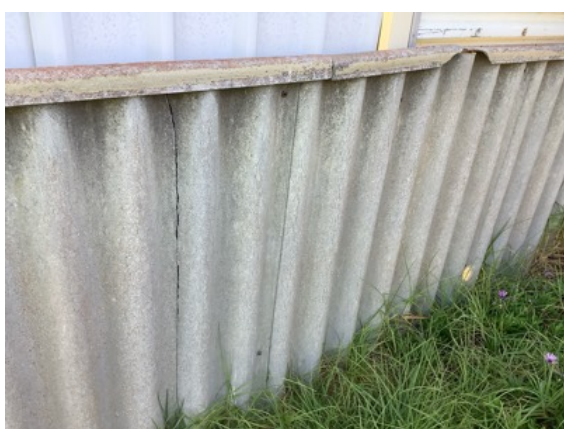
Perimeter fencing is damaged in some areas and likely to contain asbestos material. Recommend repairs taking caution when repairing using appropriately qualified contractors and safety precautions.

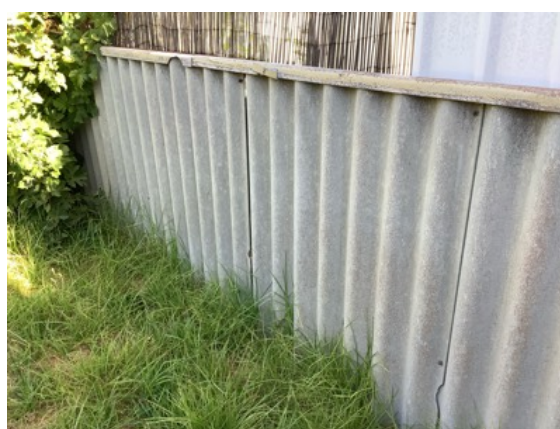
Damaged fencing likely to contain asbestos.
