15 Anzac Avenue Sandgate 4017 Queensland Australia

Pre-Purchase Standard Property & Timber Pest Report

Report number:	1543628
Inspection Date:	08th Apr, 2024
Property Address	15 Anzac Avenue Sandgate 4017 Queensland Australia

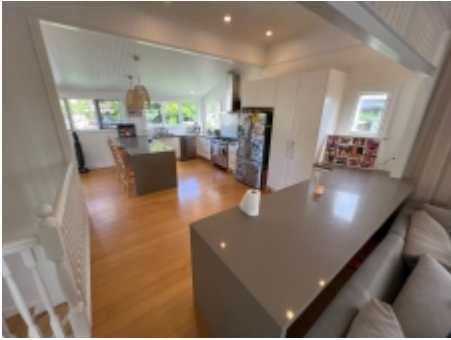
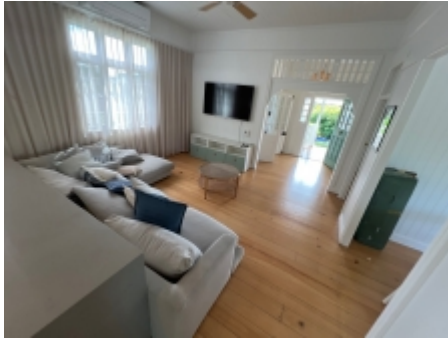
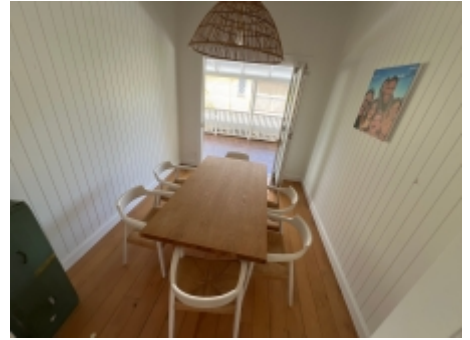
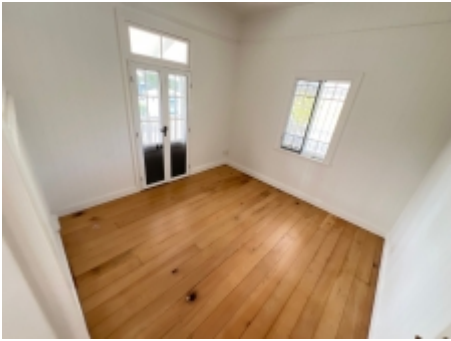
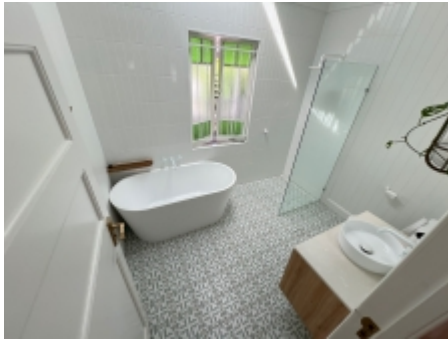
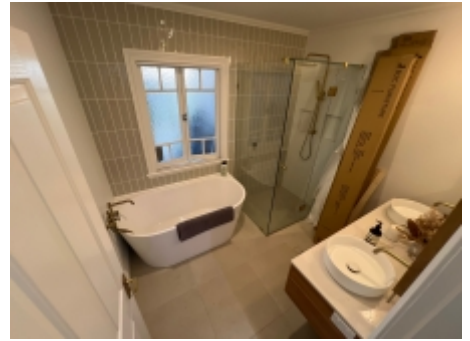
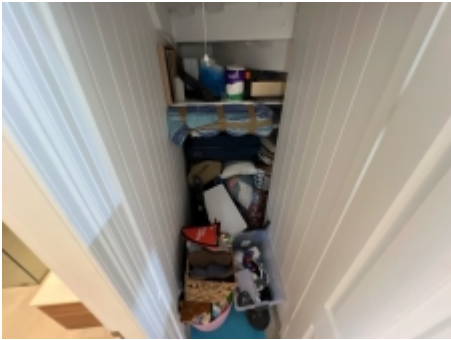
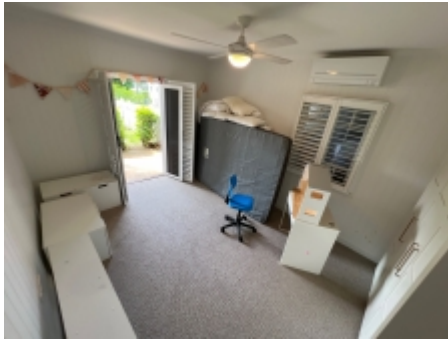
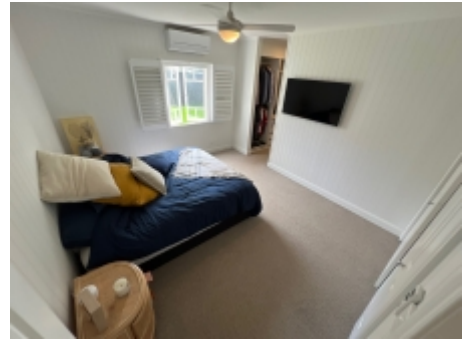
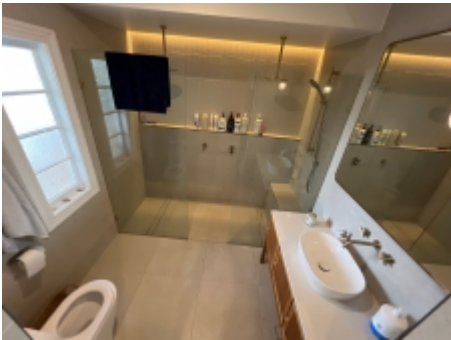
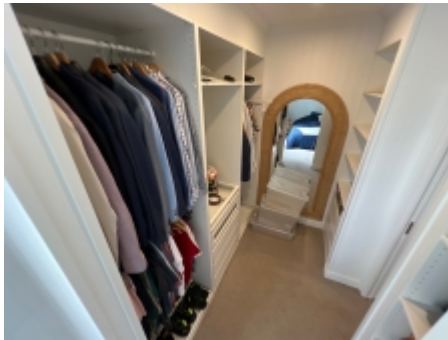
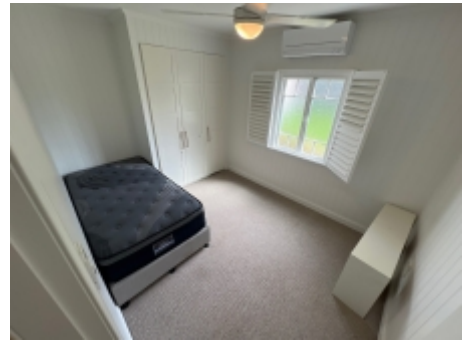
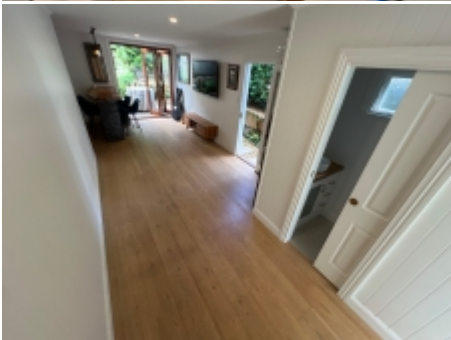
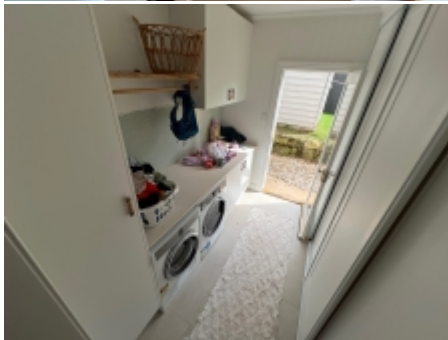
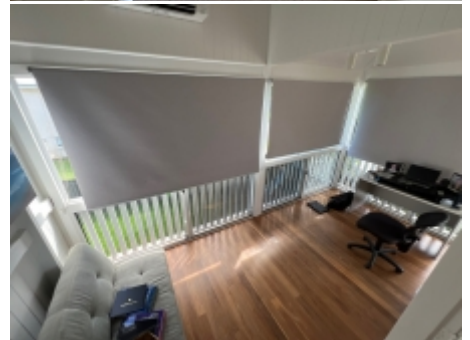
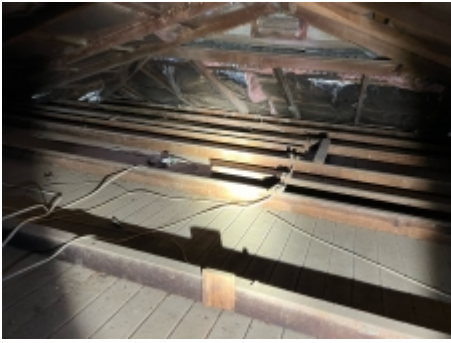
Obstruction Photos

The following obstructions may conceal defects:

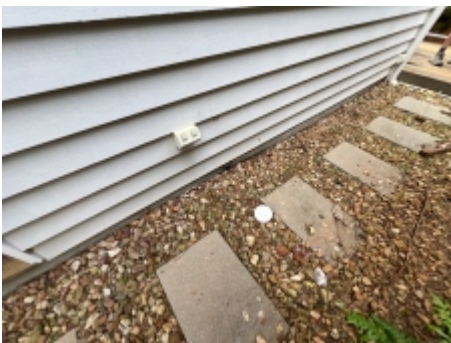
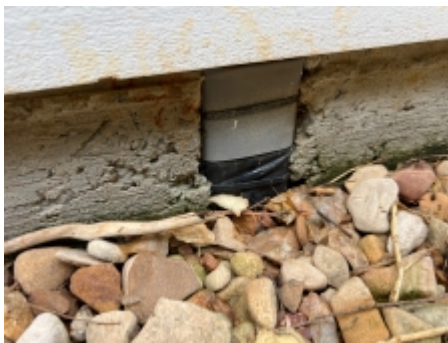
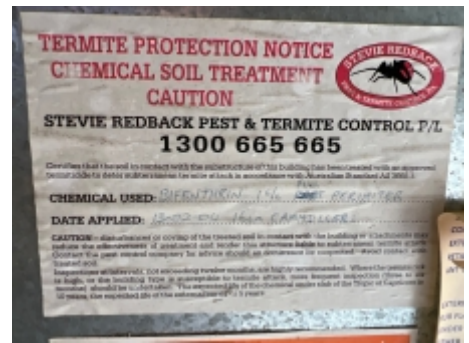
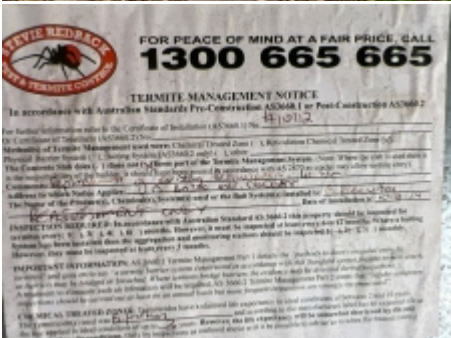
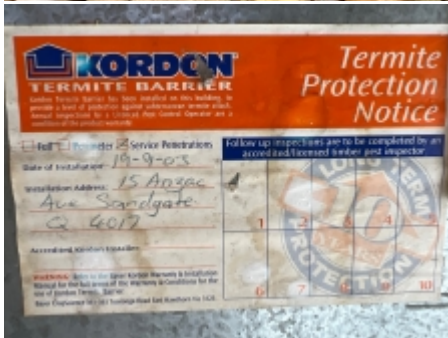
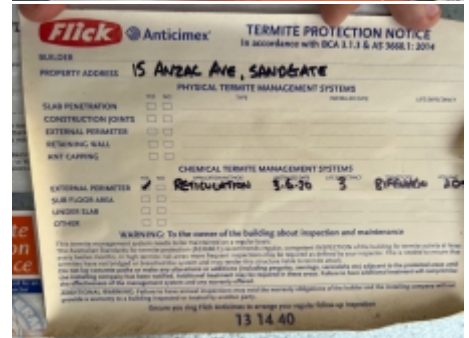
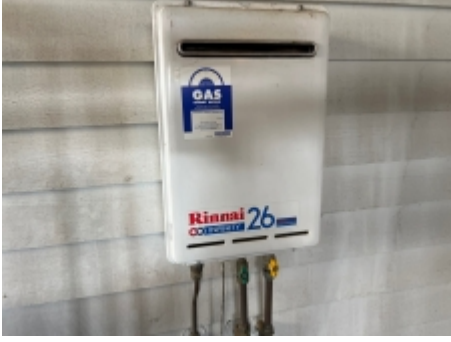
Previous Treatment Photos

E1 Active (live) termites	No evidence was found
E2 Subterranean termite management proposal	A Proposal is recommended
Additional Comments	A management proposal is always recommended. A pest controller should be engaged for further advice.
E3 Termite workings and/or damage	No evidence was found
E4 Previous termite management program	The following evidence was found:
Evidence of previous program:	Treatment sticker in meter box, Evidence of chemically treated membrane
Additional Comments	Previous pest controller should be engaged for further advice regarding warranties.
